MARIBOR – TEZENSKA STREET SLOVENIA

RECONSTRUCTION OF STREET LIGHTING TO LED TECHNOLOGY

Report created by Slolux d.o.o., Martin Vovk, dipl. ing. el.

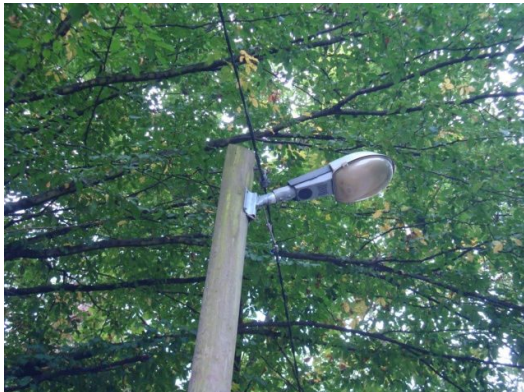
Lamp before reconstruction

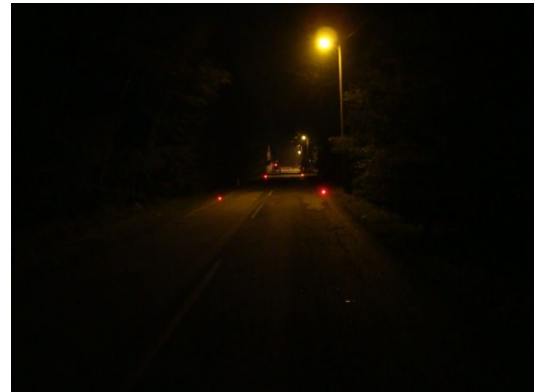
Illumination before reconstruction

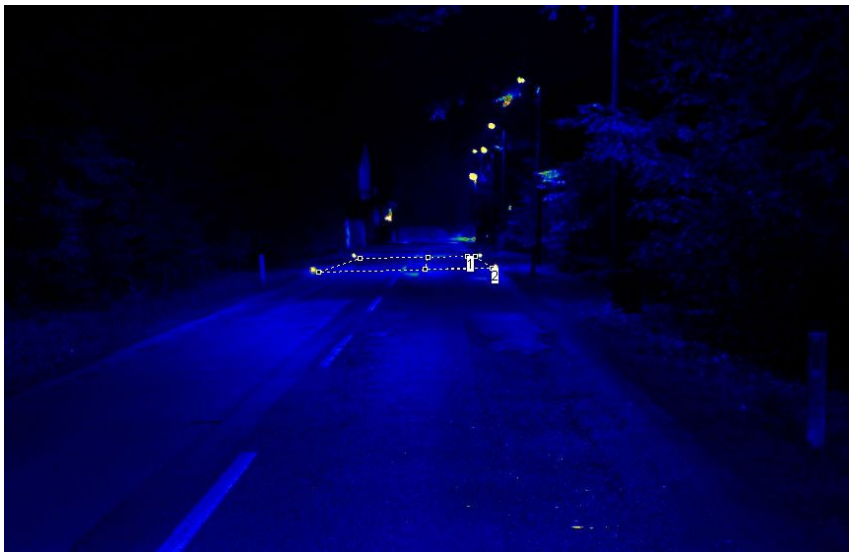
Brightens before reconstruction

Middle value of brightness is 0,13 cd/m²

Middle value if illumination is 2,9 lx

Uniformity of illumination is not measured because of long distance between the poles. Measured values are expected, because of long distance between the poles even with most advanced lamps the requested value according to the road class requirements could not be met.

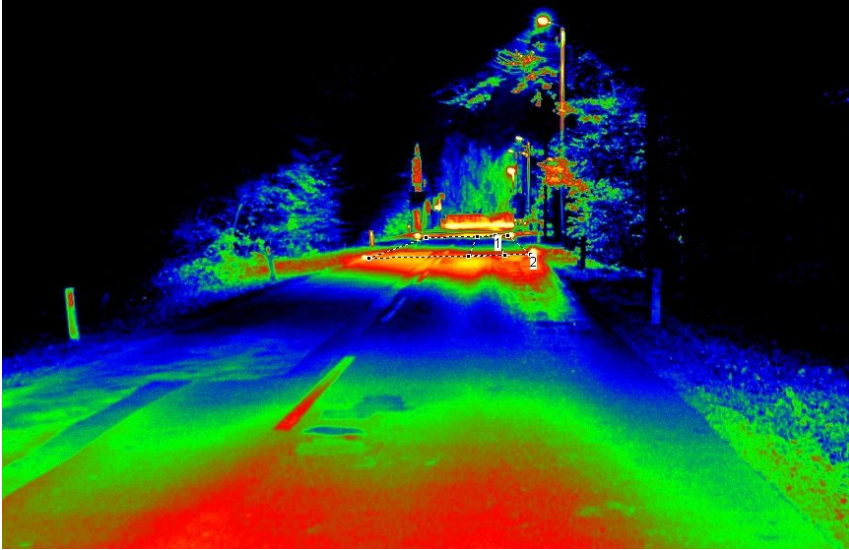
Brightens after reconstruction

Middle value of brightness is 0,2 cd/m²

Middle value if illumination is 4,1 lx

Uniformity of illumination is not measured because of long distance between the poles. Measured values are expected, because of long distance between the poles even with most advanced lamps the requested value according to the road class requirements could not be met.

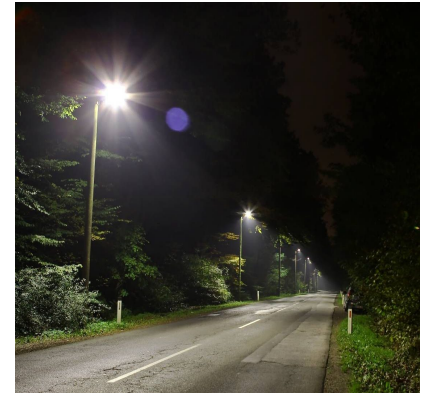
Lamp after reconstruction

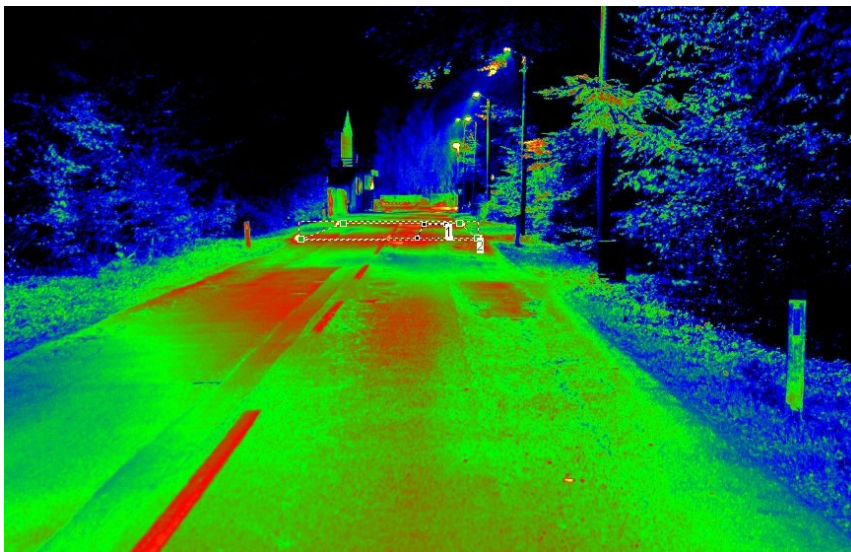
Brightens after reconstruction

Middle value of brightness: 0,51cd/m²

Minimum value of brightness: 0,21 cd/m²

Maximum value in direction of observer: 0,69 cd/m²

Minimum value in direction of observer: 0,31 cd/m²

$U_0 = 0,41$ (standard requirements 0,35)

$U_L = 0,45$ (standard requirements 0,40)

There were installed 3 more lamps on additional poles so distance between teh poles is 30m
